Issue #1, Winter 2009

The Lookout

USS Nezinscot Exploration Report

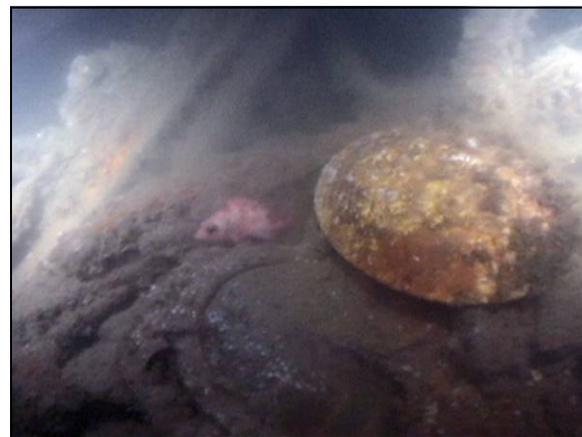
A porthole and a china dish on the wreck of the Nezinscot

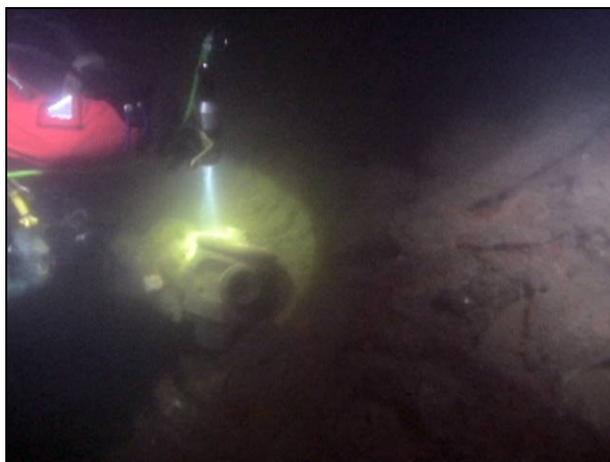
Eric Takakjian illuminates the Nezinscot's fire monitor

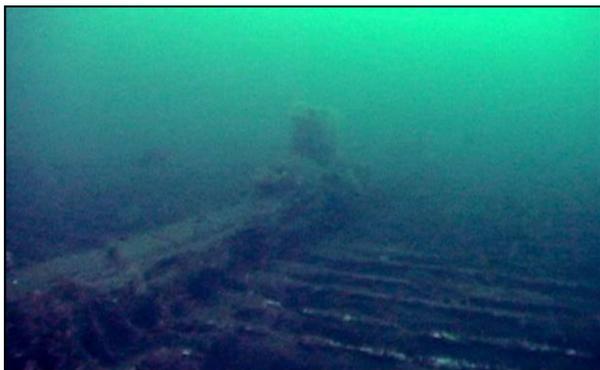
A view of the keelson with ribs perpendicular, stretching out about 15-20 feet on each side.

the contiguous wreckage. Near the wreck, there are what appear to be the remnants of a carved bow ornament. The ribs are home to lobsters and codfish – which are plentiful on this wreck. There is some derelict fishing gear along the edge of what appears to be the port side of the vessel. The visibility tends to be excellent with 25-35 feet of visibility, depending on the tide and conditions. Overall, while this is a fairly small wreck site (relative to the original size of the vessel), it's an interesting dive with pleasant conditions that affords excellent opportunities for photography as well as training.

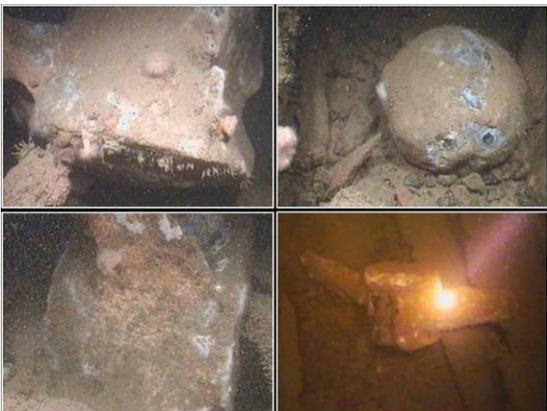
Photos of whale remains that can be found among the wreckage of the Lieut. Sam Mengel.

found largely intact, listing to port. As is typically the case, the deck planking has long since degraded, but the hull and cross beams remain relatively intact. The wreck has approximately 10-15 feet of relief, depending on location. A considerable amount of derelict fishing gear can be found on this wreck, some of which is suspended as high as 20 feet into the water column. This dictates even greater care to be taken when diving on this wreck, because of the often low visibility found here. Unfortunately, the visibility usually varies around 10 feet, though 15-20+ feet can be seen if the conditions and tide are just right. The best time to dive this wreck for visibility seems to be the May to early July timeframe when the water is still fairly cold. A good amount of coal can be found among the wreckage in addition to whale bones. The wreck contains numerous pieces of vertebrae and skull belonging to a whale – possibly a humpback given their prevalence in these waters. It has been speculated that the whale became entangled in abandoned fishing gear and drowned. As a note, whale remains are considered protected and should not be removed or disturbed, and given the unique nature of this wreck, leaving the whale skeleton as it is preserves the integrity of the site. This is a more challenging wreck due to the combination of low visibility and derelict fishing gear, but its uniqueness makes the dive extremely worthwhile.

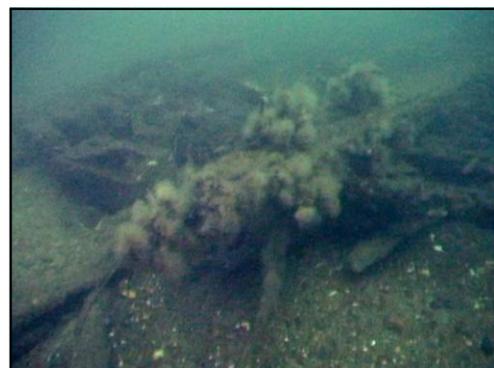
The contiguous wreck abruptly ends with some scattered wreckage and debris in the surrounding sand.

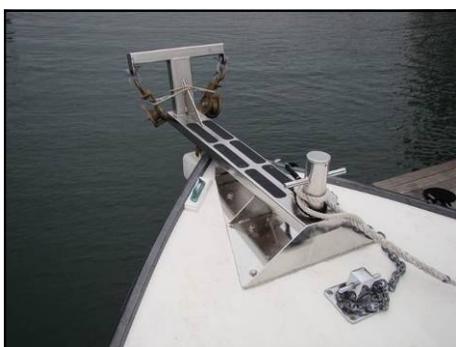
Gauntlet's new bow pulpit

The “business end” of a dive boat is definitely in the bow since this is where we are tied off to buoys or anchors. Usually, there is very little scope in the line when we are tied into a wreck to ensure a fast descent and provide a solid line to use as a reference. The downside of this is that it puts significantly more stress on the bow roller and deck cleat since there is less line to absorb the shock of the boat bucking in the seas. In order to distribute the force more evenly to avoid damage and make it easier for the crew to work with lines while getting the boat secured in rough seas, we decided to install heavy duty equipment. Our new bow pulpit is based off of a design in use aboard the R/V Quest. Our friend Eric Takakjian of Quest Marine Services designed one with us specifically for the Gauntlet and then constructed it for us! The pulpit is made of 316 grade stainless steel and has been welded together and electro-polished so that it will always have that “new” look to it. We installed Hancock Blocks on either side of the pulpit's horizontal bar, which in addition to having a roller in the block that makes it easy to handle lines, also rotates so that the line can move about more freely, further reducing strain on the boat.

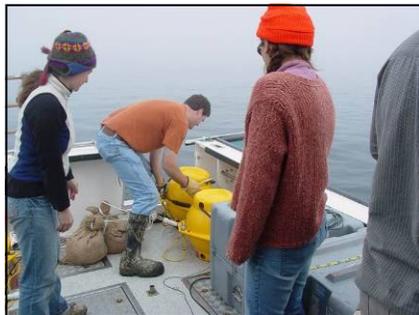
Researchers prepare to deploy pop-up buoys for acoustic recording experiments

Other types of monitoring equipment include marine acoustic recording units (MARUs), also known as “pop-up” buoys. These are placed in chosen locations throughout the terminal corridor and areas of influence to record longer-term data at

three month intervals. Since these are submerged and are literally resting untethered on the seafloor, periodically they need to be retrieved for data download and maintenance. The MARUs have a self-release mechanism that can be initiated by a researcher using a programmed acoustic sequence. The buoy floats to the surface and is retrieved by the boat. Sometimes the pop-ups get moved inadvertently by fisherman trawling/dragging or the batteries die before retrieval and divers are needed to search for them. This work is slated to continue through at least 2012 and Gauntlet will remain involved as needed.
