MANIFEST

The Return of the Patriot

The Hollis PRISM 2 CCR

THE LOOKOUT

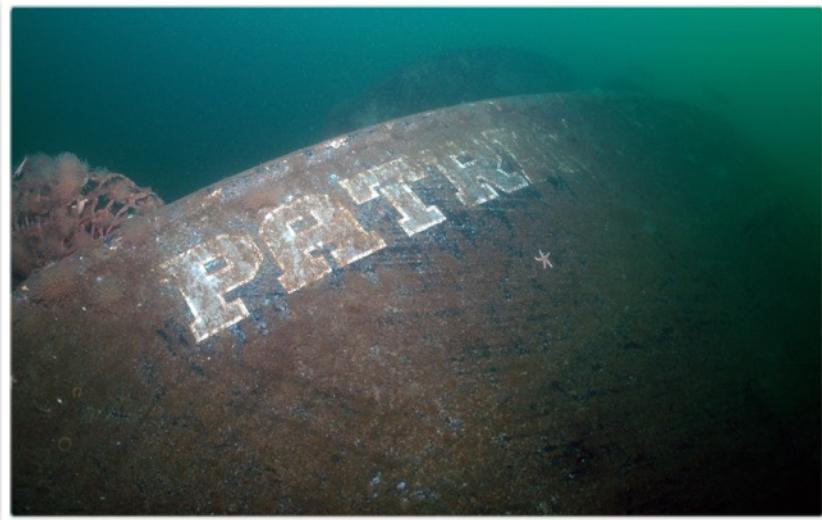
The Patriot in 2012; the name was still visible on the port side hull.

The Patriot came to rest in 100 feet of water on Stellwagen Bank approximately 15 miles off Gloucester, MA. After the Coast Guard investigation concluded, salvage and survey divers studied the wreck extensively, looking for clues and alternative explanations as to the cause of the sinking. The starboard side of the wreck held particular interest because some believed the wreck may have been struck on that side. Since the wreck was resting on its starboard side and that section was not accessible, pieces of the wreck were cut away to expose possible damage from a collision on the starboard side. Eventually the site became so contaminated by the effects of nature and salvage attempts that no new information to suggest another scenario ever emerged. Meanwhile, the Patriot became a popular dive site for recreational divers looking to experience diving in Stellwagen Bank National Marine Sanctuary. But then the Patriot vanished.

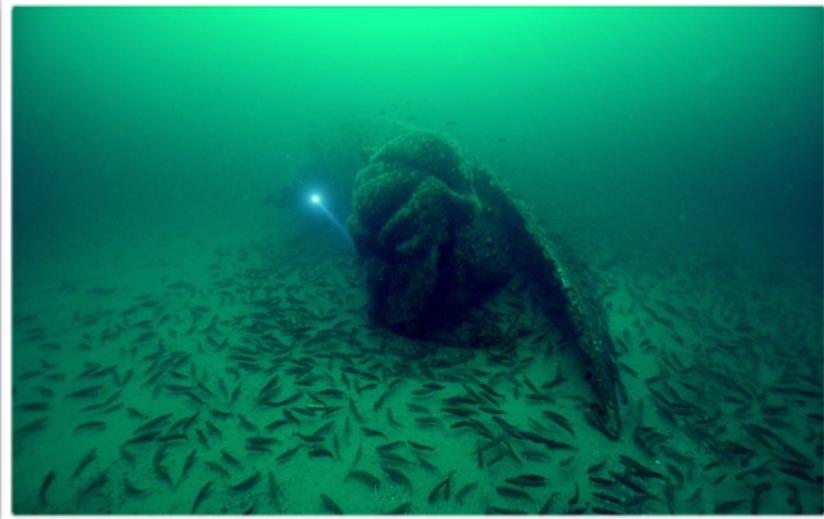
The Patriot in 2014. The wreck is heavily sanded in and in this photo, surrounded by hake. The visibility on this dive was approximately 50 feet.

Upon descending to the Patriot, we found the wreck to be in a shockingly different condition. Indeed, it was on its starboard side and relatively intact; however, the wreck was considerably buried in the seafloor and all of the fishing gear was gone. The wreck appeared to have been uprooted from the bottom and may have even rolled as if it were a tumbleweed on the bottom, ripping many of the deck structures away before burrowing into the sand again. The pilot house door on the port side was jammed closed. Some derelict fishing gear remained, mainly in a tangled mass about amidships. For sure, the Patriot did not appear to be the same wreck.

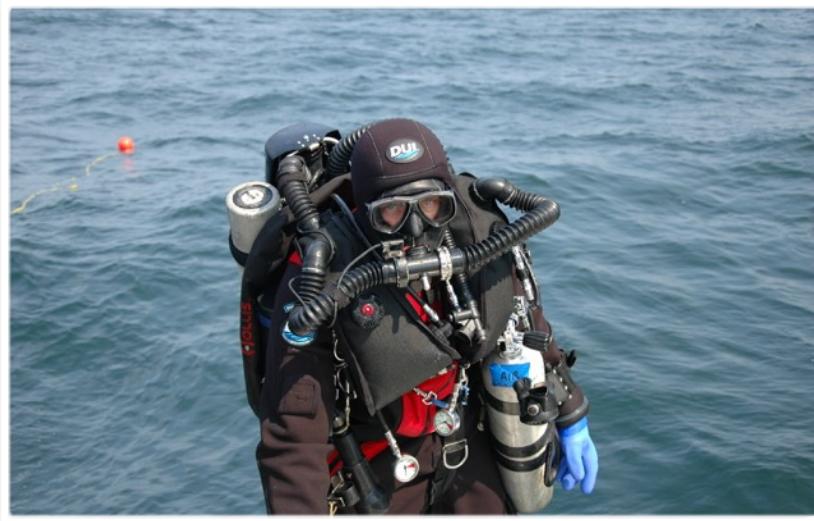
The Hollis PRISM 2 rebreather.

Hollis is part of the AUP group, one of the largest dive equipment manufacturers in the world. Hollis brings the capability of manufacturing the PRISM at a large scale and with a greater degree of quality control. In addition, Hollis created an upgradable platform that incorporates the latest technology. Hollis preserved many of the key features of the Topaz in the PRISM 2 design and made some noteworthy improvements:

- Utilization of more durable materials and improved manufacturing
- Keyed fittings that can be assembled only one way to reduce the risk of improper assembly

- State-of-the-art PID (Proportional - Integral - Derivative) Control loop feedback circuitry. The PID controller controls the solenoid and utilizes an algorithm that incorporates both history of what has occurred and predictions for what may occur in the future to make "decisions" about oxygen injection

- Incorporation of the Shearwater Petrel dive computer, including the DiveCAN standard, which allows for use of different devices and ensures error-checked communications

- Ability to incorporate in Generation 3 units the Shearwater NERD (Near Eye Remote Display)
- Modular design that compartmentalizes the solenoid and oxygen electronics (SOLO), which allows for the unit to be operated independently of the handset

- Optional Bail-Out Valve (BOV)
- Optional Back-Mounted Counterlungs

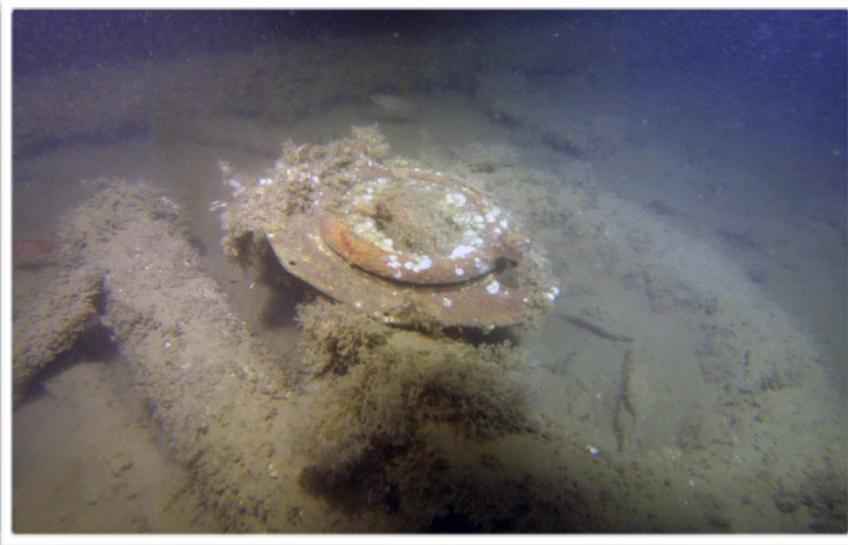
A porthole on the Unknown Wreck 114.

In the fall of 2013, the team located an obstruction on the sea floor in 240 feet of water. The obstruction was confirmed to be a shipwreck. The site primarily consists of a large upright two cylinder compound steam engine amidst a debris field. A small portion of the top of the boiler and a propeller is visible. However, much of the hull structure lies beneath the sea floor. Based on cylinder diameter measurements, the team excluded several potential matches. Although the identity of this shipwreck remains elusive, the team's current thinking is that the vessel sank sometime after 1917 and may be that of a steam trawler.
